COLLISION REPAIR INFORMATION

TITLE: QUARTER PANEL SECTIONING
(CUT-P) PROCEDURE

SECTION: EXTERIOR BULLETIN #85

MODELS: ALL TOYOTA /LEXUS

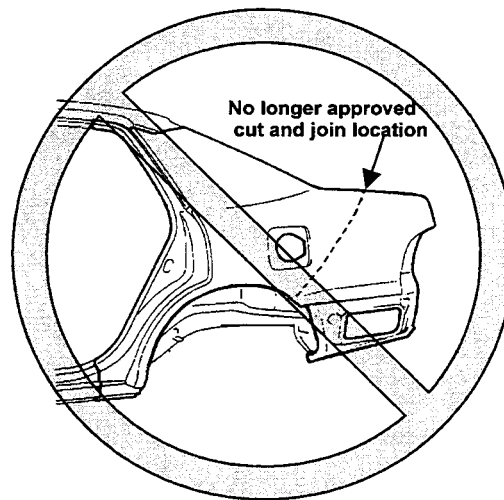
The Quarter Panel Sectioning (CUT-P) procedure, as shown in Toyota and Lexus Body Collision Damage Repair Manuals, and sometimes referred to as “vertical cut” is **no longer an approved** repair procedure (when replacing a damaged quarter panel) of any Toyota or Lexus vehicle. (see illustration below)

Research indicates this procedure may not satisfy customer expectations in terms of visible repair quality. This repair is viewed primarily as a potential cost-savings process.

Toyota no longer approves of this CUT-P procedure for some of the following reasons:

- Visible cut and join locations from inner trunk compartment
- Body character lines are difficult to weld across
- Very difficult to perform an undetectable repair
- Customers overall cost of ownership is not reduced

Future Collision Damage Repair Manuals will not include the Quarter Panel (CUT-P) procedure.

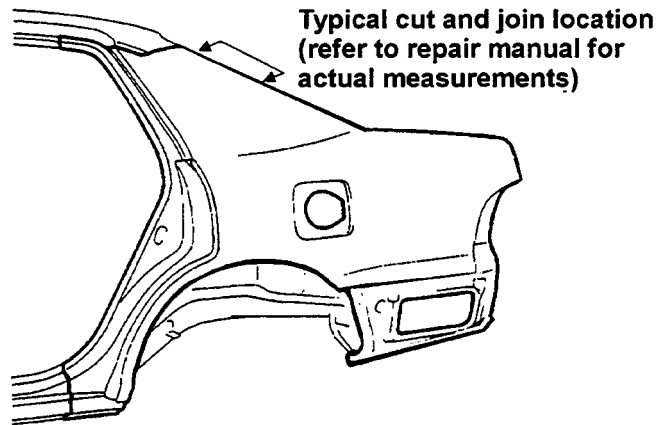
The appropriate removal and installation specification for Quarter Panel sectioning are illustrated in each model-specific Repair Manual for Collision Damage, Body Panel Replacement section-Quarter Panel (CUT) procedure. The graphic below illustrates the typical cut and join location.

Always refer to the Toyota/Lexus model-specific repair manual for the actual cut/join location measurements, welding requirements and other important information.
