Transverse Engine Mount - Abnormal Noise and Vibration on Acceleration

Service Category Drivetrain

Section Manual Transmission/Transaxle

YEAR(S)	MODEL(S)	ADDITIONAL INFORMATION
2007 – 2009	Yaris	Body Type(s): 3Dr. Hatch Back, 4Dr. Sedan, 5Dr. Hatch Back Transmission(s): 5MT

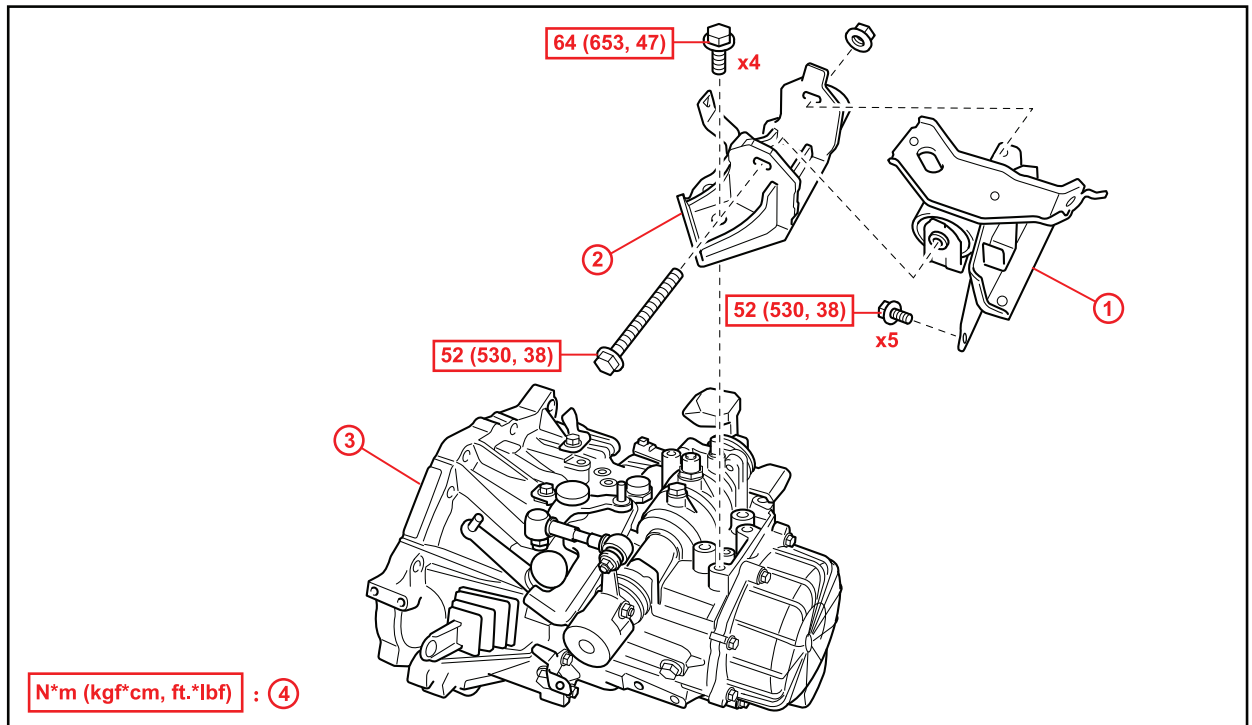
Figure 1.

Some 2007 – 2009 model year Yaris vehicles may exhibit an abnormal noise and vibration during one or more of the following conditions:

1. Confirm the customer concern.
2. Inspect the LH engine mount rubber for separation.
3. If separation is noted, replace the LH engine mount.

PREVIOUS PART NUMBER	CURRENT PART NUMBER	PART NAME	QTY
12372-21130	12372-21131	Insulator, Engine Mounting, LH	1

4. Test drive the vehicle to confirm the repair.
